+ Considérations techniques pour la planification, la conception et la construction d'un projet de transport en commun dans un milieu densément peuplé

Le cas du projet de système léger sur rail Eglinton Scarborough Crosstown

Jean Habimana, ing., PE, Ph. D.

HATCH

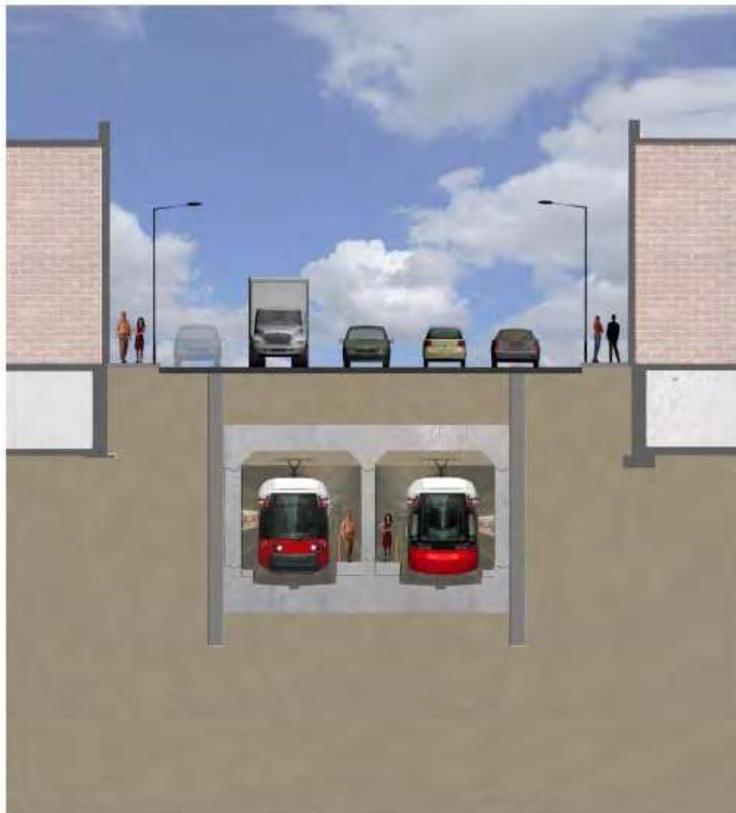
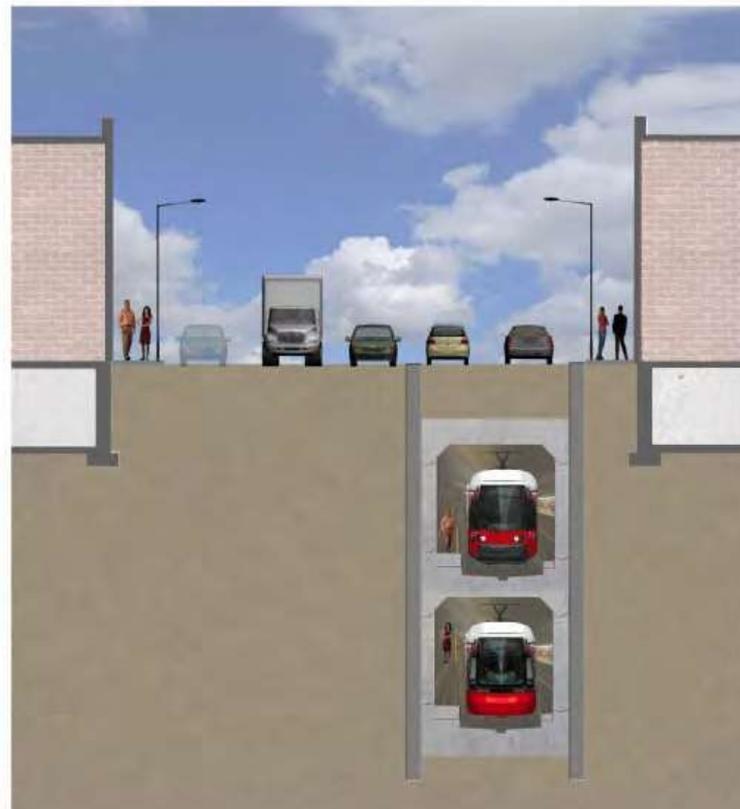
Excavation à ciel ouvert

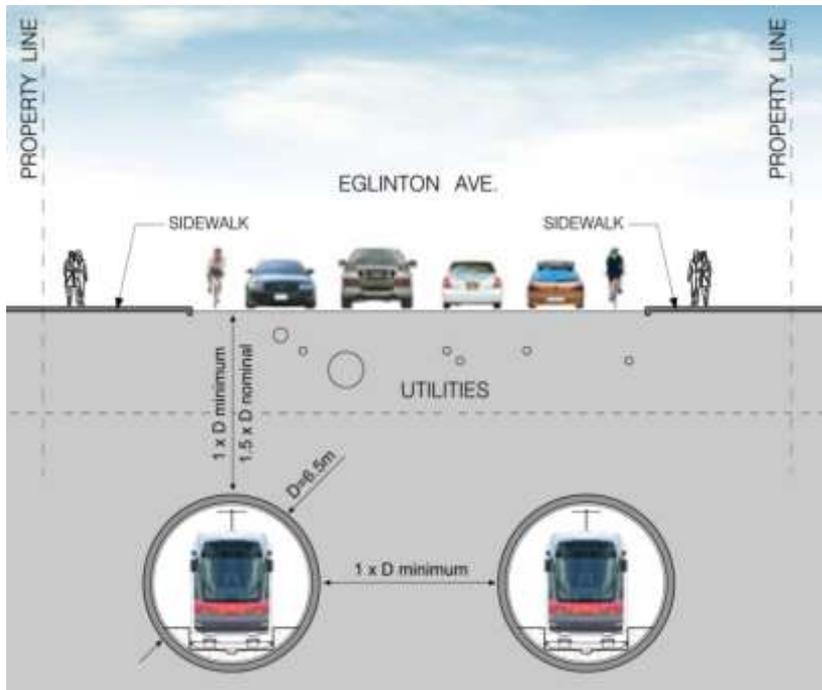
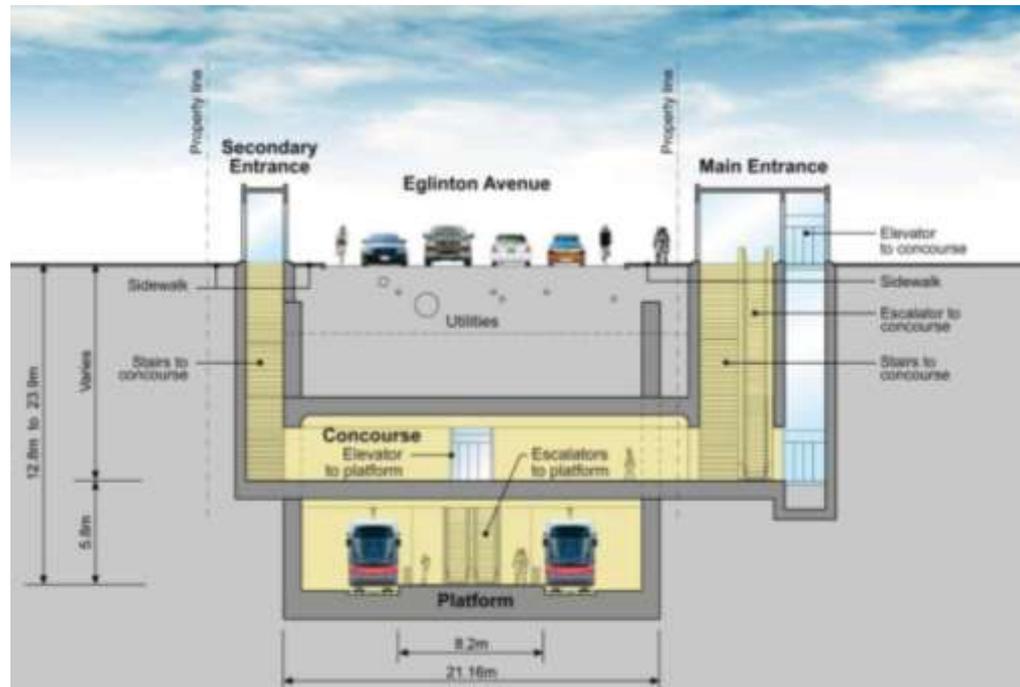
Établir la profondeur du tunnel

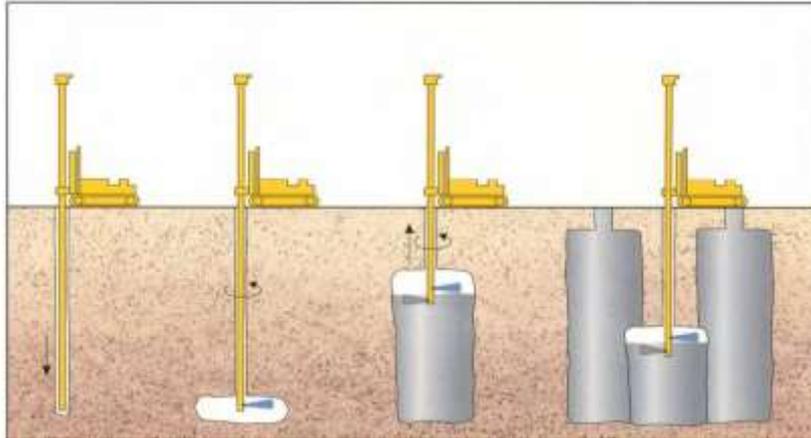
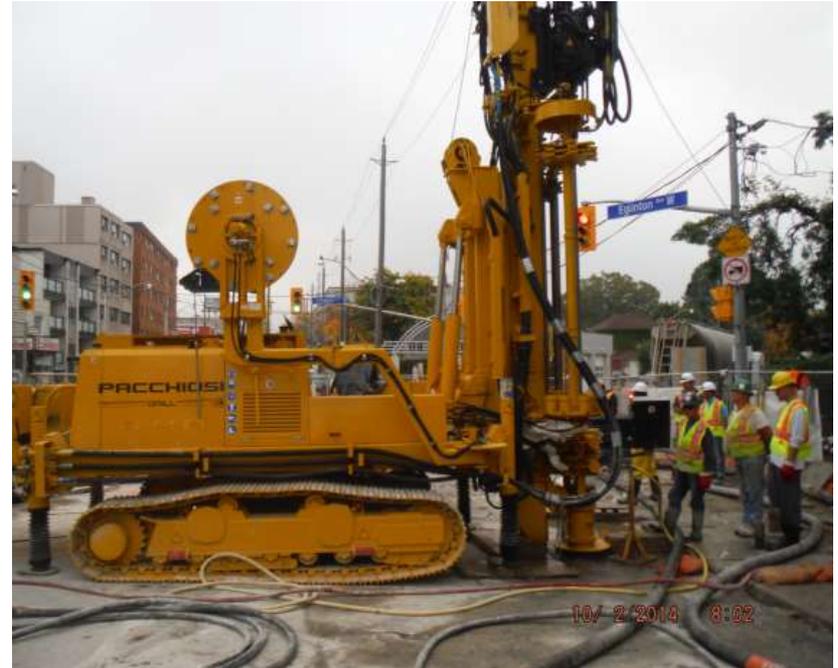
Technique de « *Jet Grouting* »

Technique utilisée pour la consolidation des sols et l'assèchement des puits profonds

Utilisation de la technique « *Jet Grouting* » pour construire les murs de têtes

- Aucune relocalisation des réseaux des utilités publiques
- Réduction des plaintes des riverains
- Réduction d'impact sur la circulation
- Réduction d'impact sur les coûts
- Réduction d'impact sur l'échéancier

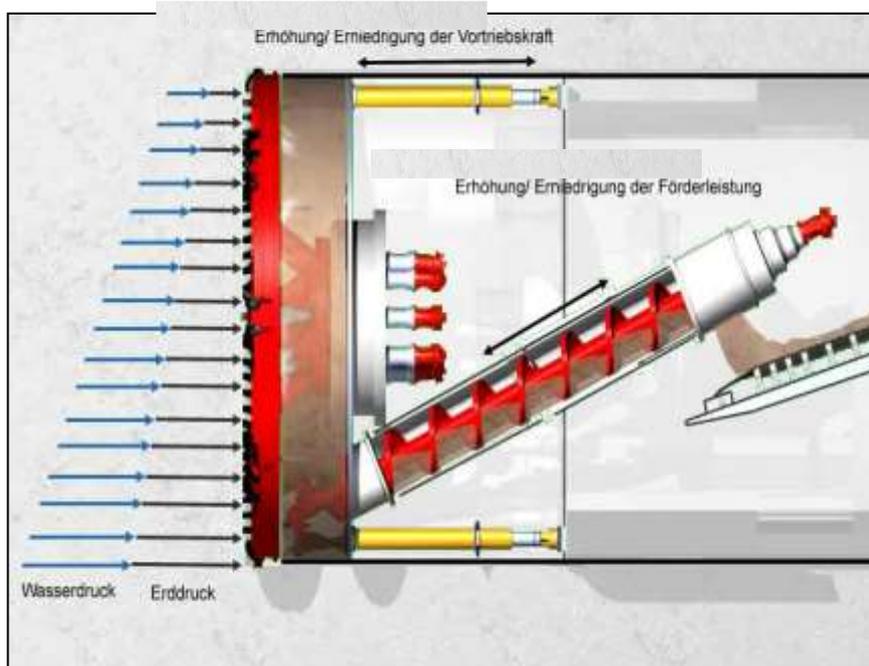
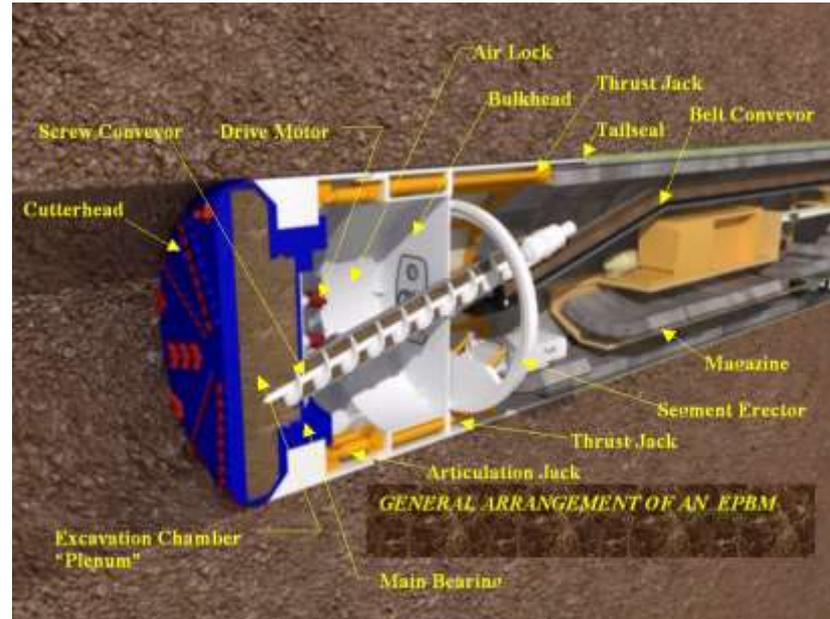
Tunneliers à pression de boue

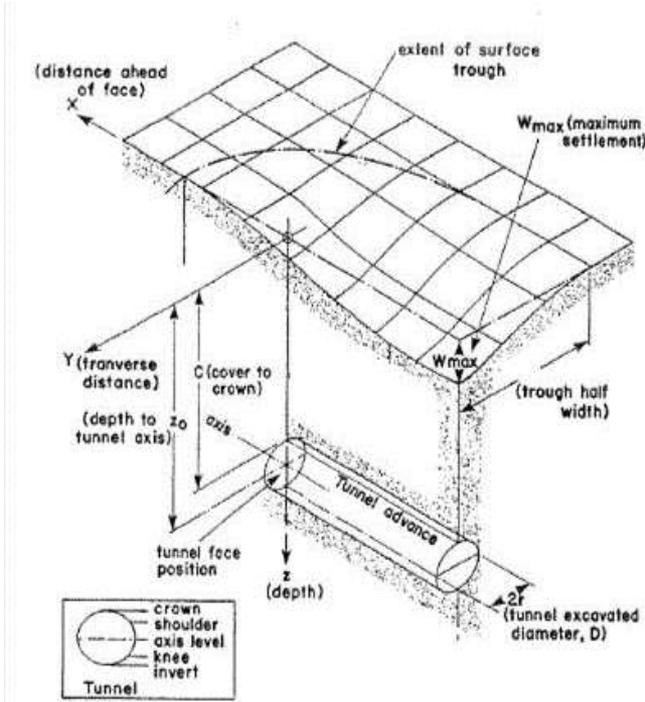
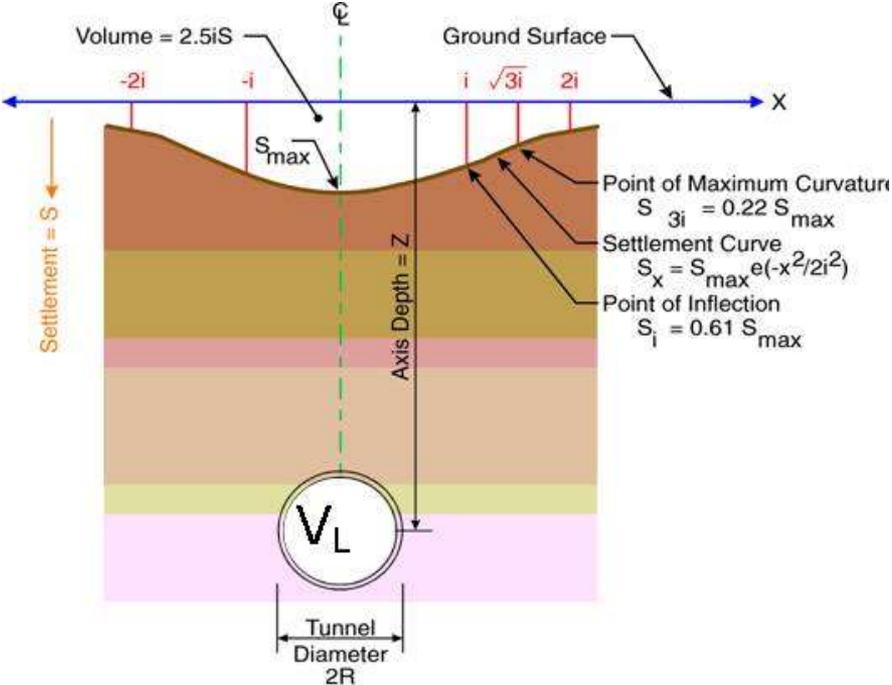
Affaissement causé par le creusement des tunnels

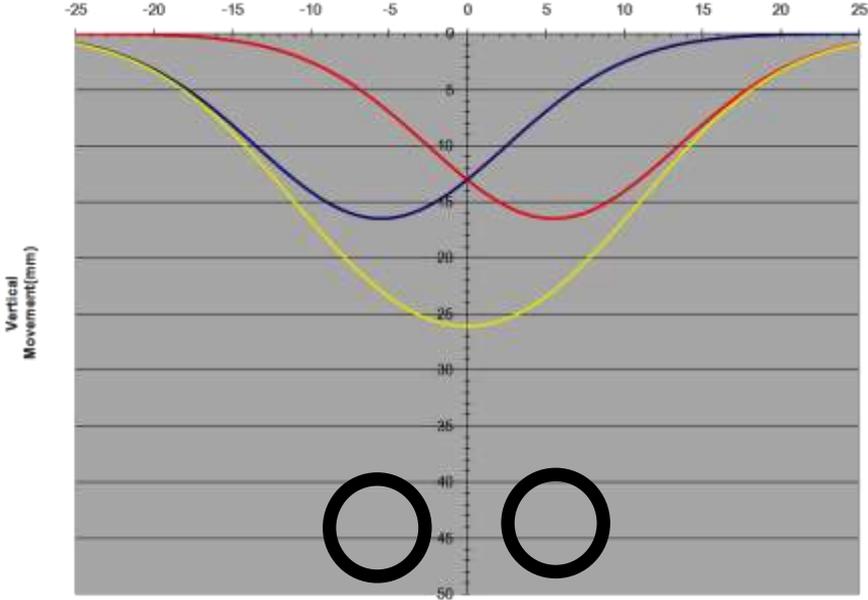
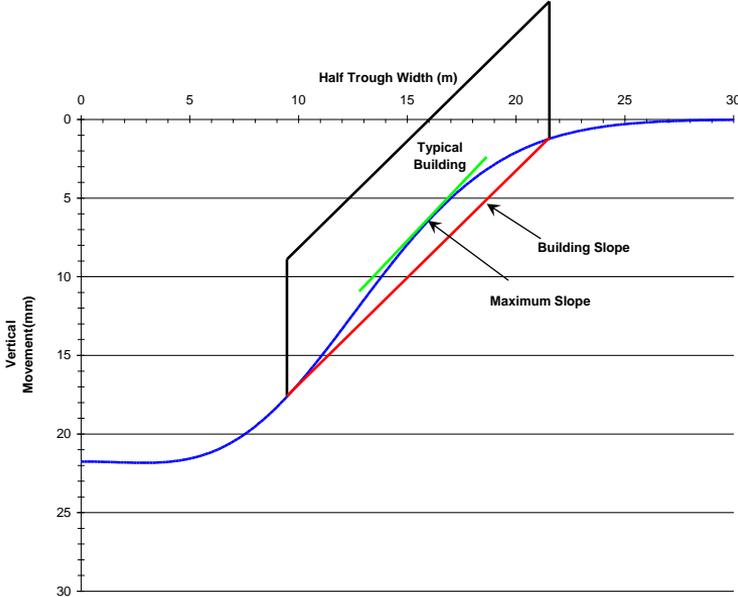
Impact d'affaissement sur les structures existantes

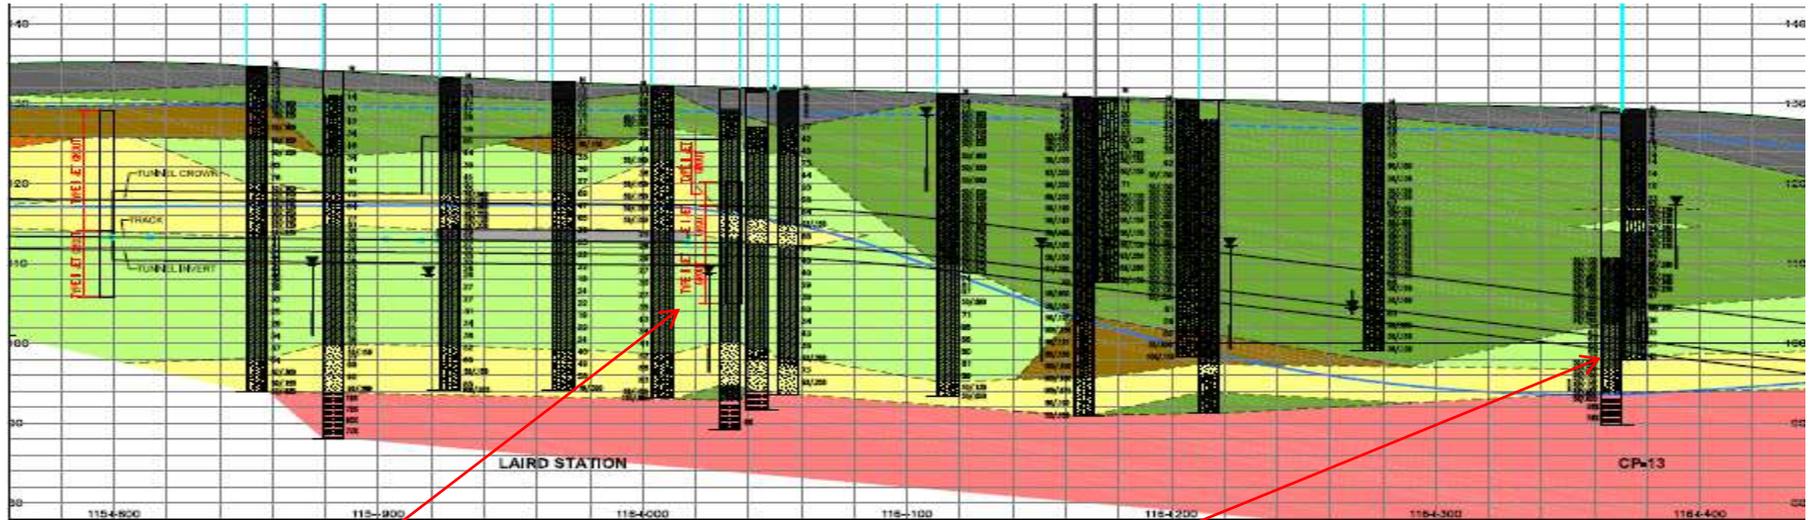
CP13

Conditions géologiques

- “Jet Grouting” aux murs de tête
 - Injection type I (matériaux non plastiques ou très tendres)
 - Injection type II (sols durs ou plastiques)

- Excavation manuelle
- Pas de venue d’eau
- Roc peu profond aux stations Laird, Don River et Don Mills

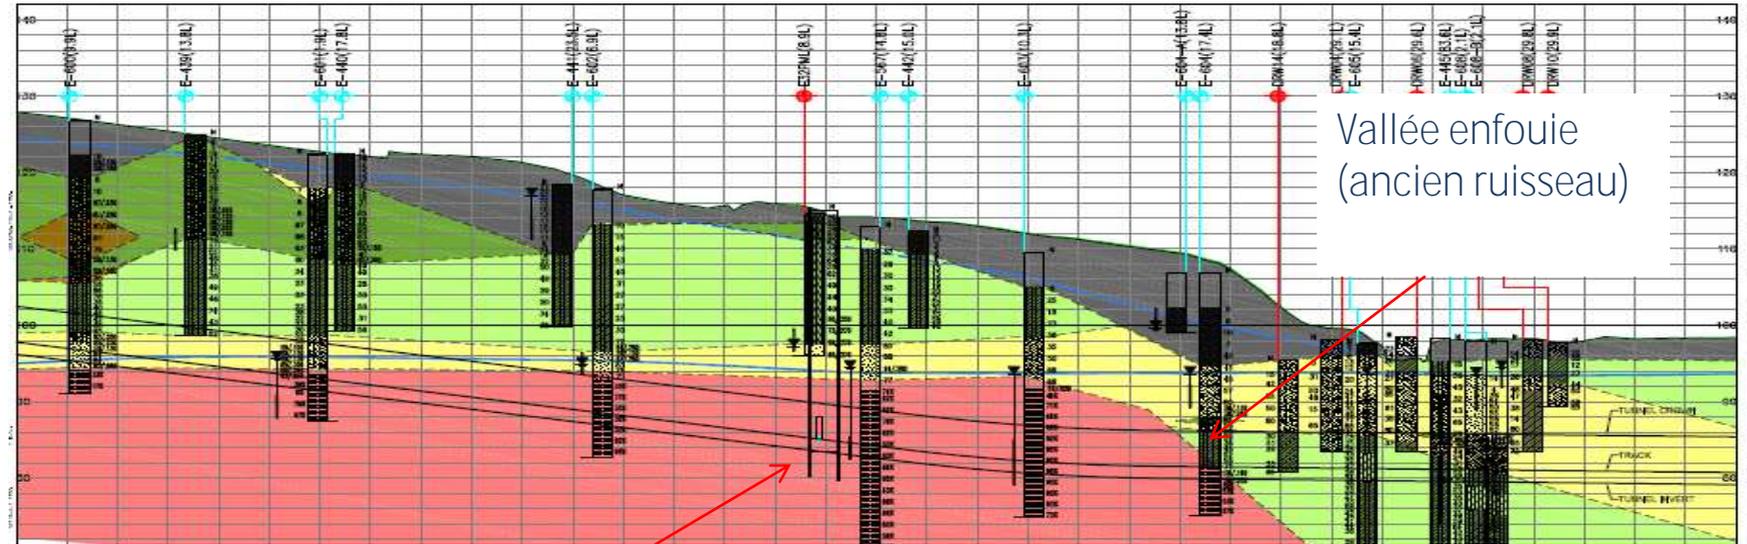
EEB - 4

Conditions géologiques : conditions mixtes

- Aucun pompage d'eau dans les sols à cause de la présence de contaminants à ne pas déplacer
- Enfoncer les murs sécants jusqu'au roc avec encastrement d'au moins 3 m

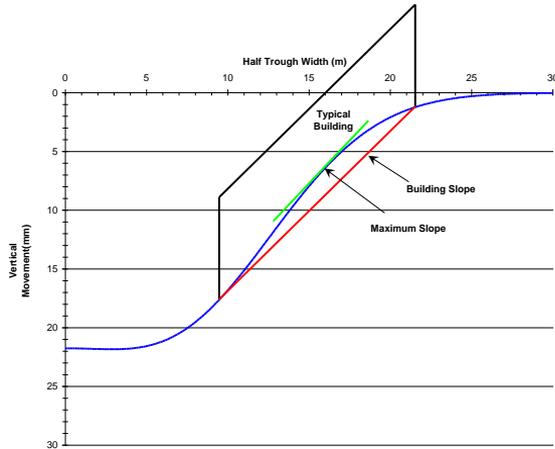
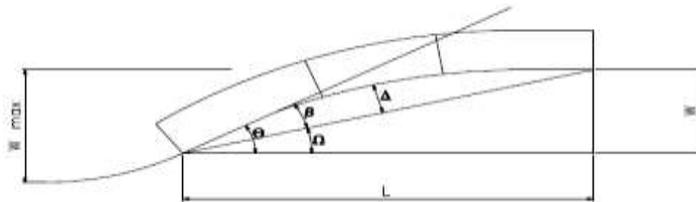
Évaluation d'impact: niveau 1 - Empirique

EDLE 1-1: Eglington Crossown LRT Twin Tunnel Level 1 Impact Prediction due to Tunnelling														Hatch Mott MacDonald		
Building Address	Description	Approximate Stationing	No. of Storeys	Depth of Tunnel Springline		Offset from Alignment Centreline (m)	Volume Loss (%)	k	Burland et al (1977)		Predicted Damage Assessment		Boscardin and Corbin (1986)		Recommended Mitigations and Comments *	
				m BGS	m USF				Maximum Settlement Beneath Building Foundation (mm)	Maximum Slope (+/-%)	Settlement Criterion	Slope Criterion	Angular Distortion β (+/-%)	Horizontal Strain ϵ_L (+/-%)		Predicted Damage Assessment
250 EGLINGTON AVE W	Wine Bar Insurance Building	113-490	3	20.88	19.288	12.9	0.5	0.4	3.8	0.034	Negligible or Very Slight	Negligible or Very Slight	0.386	0.220	Negligible	GMM + GMM + PCJ

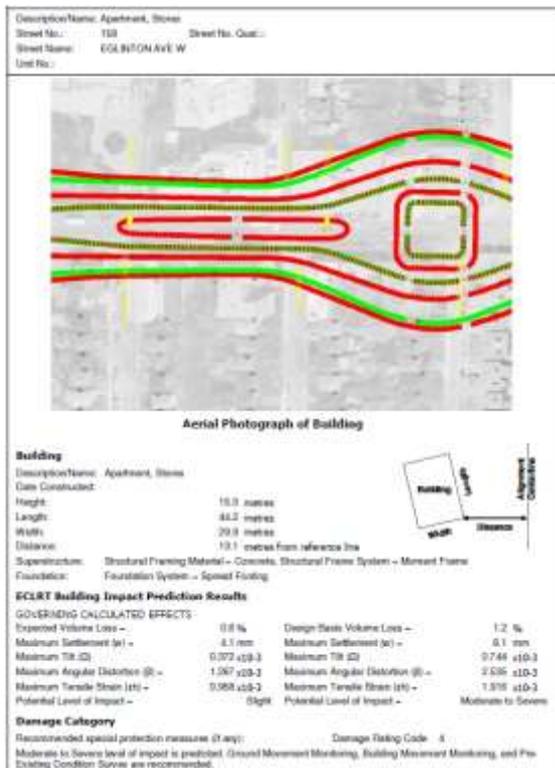
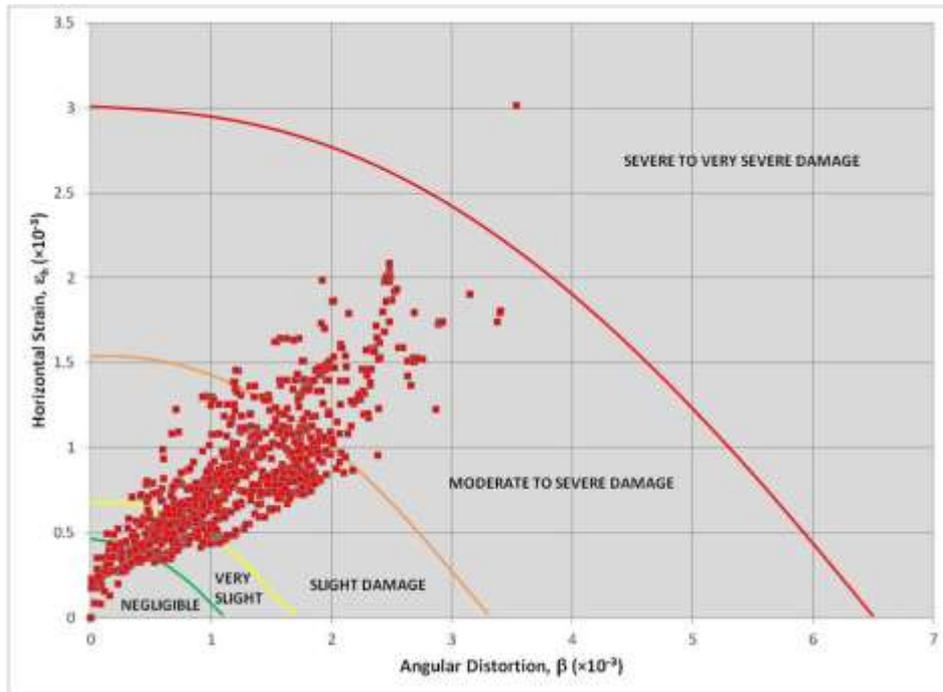
Résultat de l'évaluation d'impact: niveau 1

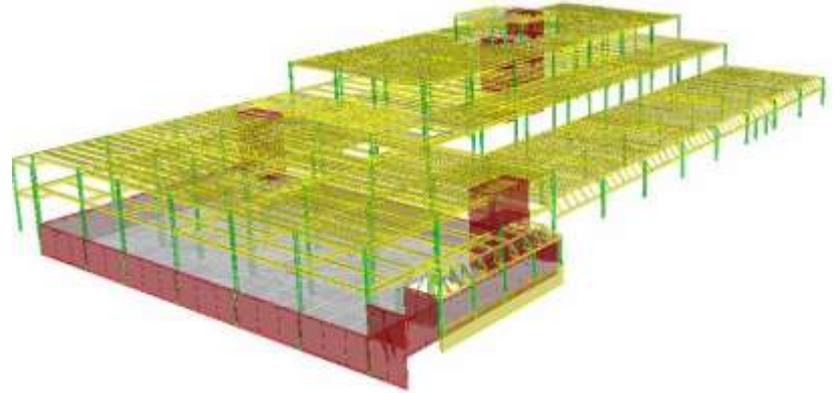
Évaluation d'impact niveau 2 – Modélisation numérique

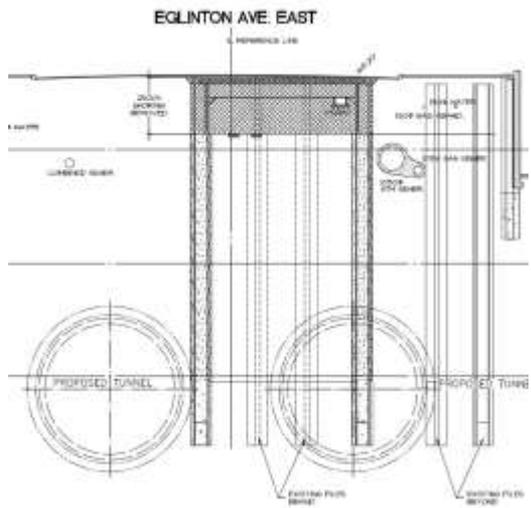
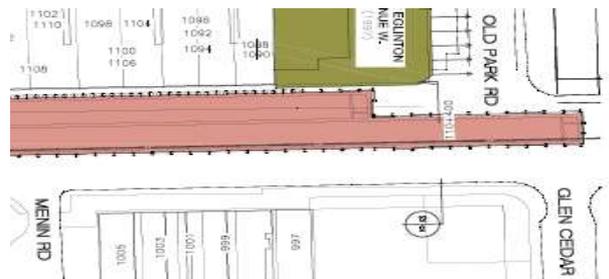
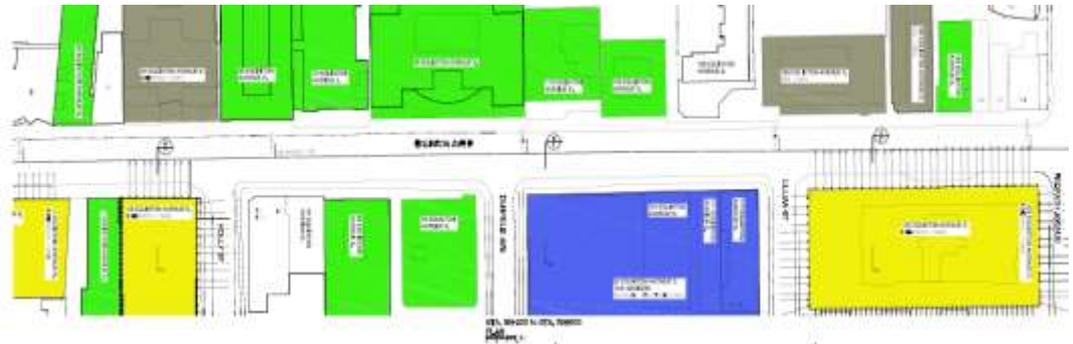
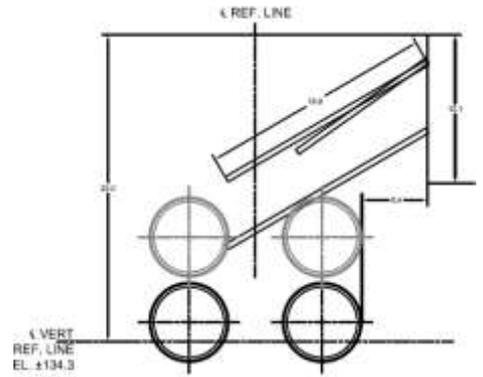
Obstructions (piles abandonnées, ancrages)

- RECORDS SHOW TIEBACK ANCHORS ENCR OACH ONTO EGLINTON AVE.
- RECORDS SUGGEST RAKERS / NO TIEBACK ANCHORS ENCR OACH ONTO EGLINTON AVE.
- SMALL RESIDENTIAL, COMMERCIAL OR OLDER STRUCTURES WITH SHALLOW FOUNDATION WITH NOT TIEBACK EXPECTED
- PROPOSED STRUCTURE (POTENTIAL FOR PRESENCE OF TIEBACK ANCHORS)
- POTENTIAL FOR PRESENCE OF TIEBACK ANCHORS
