Rijkswaterstaat Ministerie van Infrastructuur en Milieu

Refurbishment of the Velser Tunnel (The Netherlands)

Ronald Mante

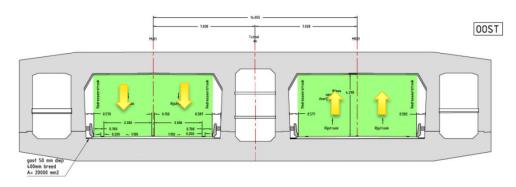
Tunnel characteristics:

- Two uni-directional tunnel tubes, each with 2 lanes
- Total length: 1,664m (about 1 mile)
- Length closed section: 768m
- Very low ceiling → height detection system to detect and stop over height trucks
 → hindrance for traffic

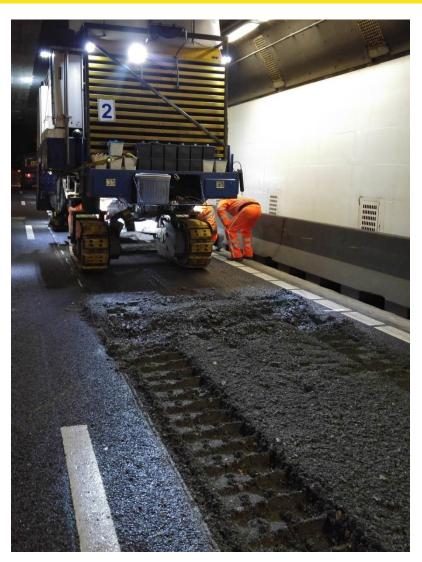
Standaard doorsnede gesloten deel

Increase of height clearance (0.12m \approx 4.5 inches) by:

Tunnel ceiling: removal of ceiling ridges

Tunnel floor: removal of old concrete road pavement underneath asphalt

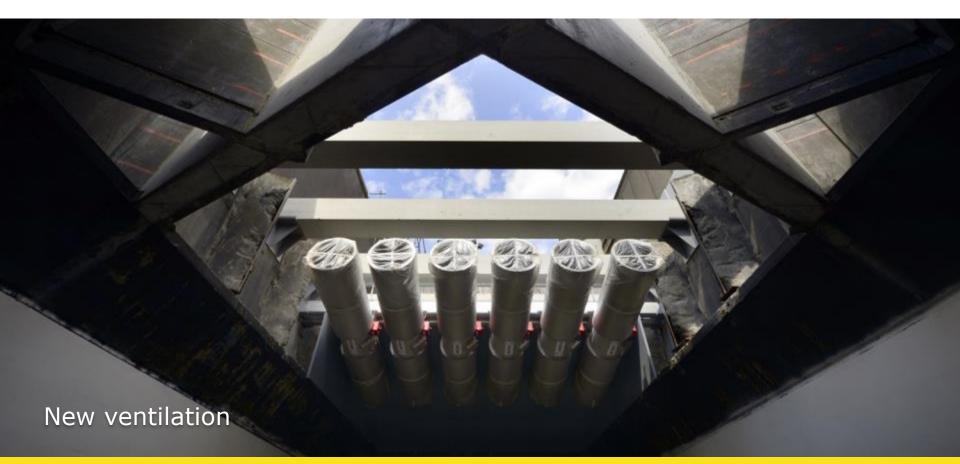
Closing of old ventilation holes (2,200 holes)

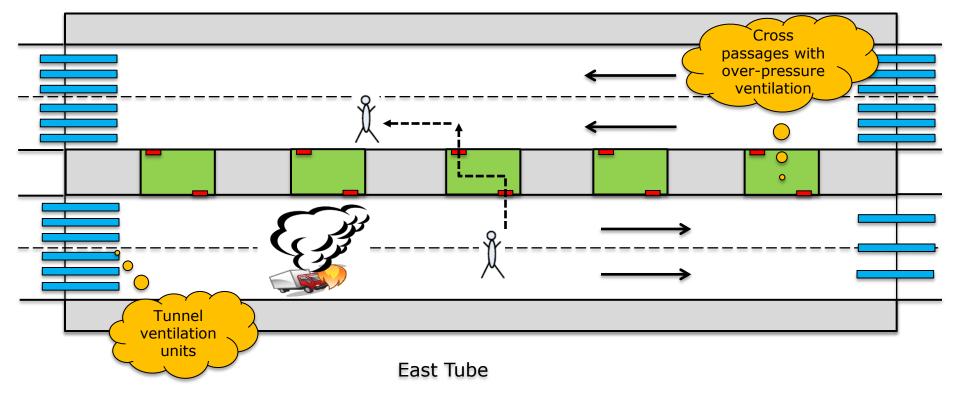
West Tube

Initial concept

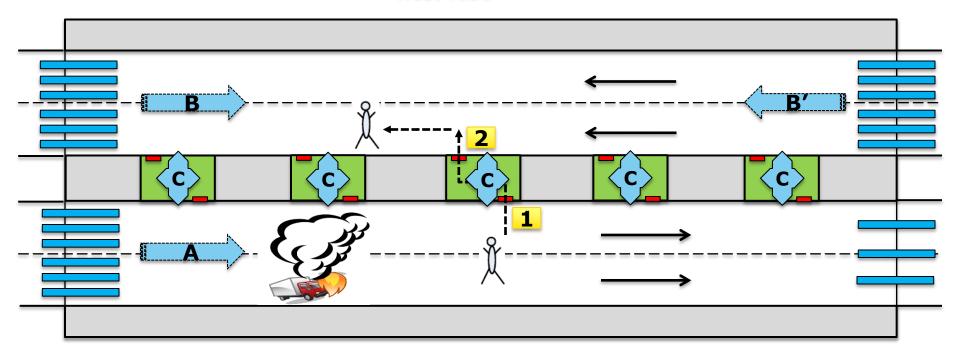
West Tube

Optimized concept
