LA MOBILITÉ AU SERVICE DE LA SÉCURITÉ

ÉTUDE DE CAS LONDONIEN :
LES OUTILS POUR RÉDUIRE LES ENJEUX DE SÉCURITÉ
RELATIFS AUX AUTOBUS DANS UNE INTERSECTION

Kensal Rise Corridor Study
Stage 1 Road Safety Audit
Report for London Borough of Brent
February 2018

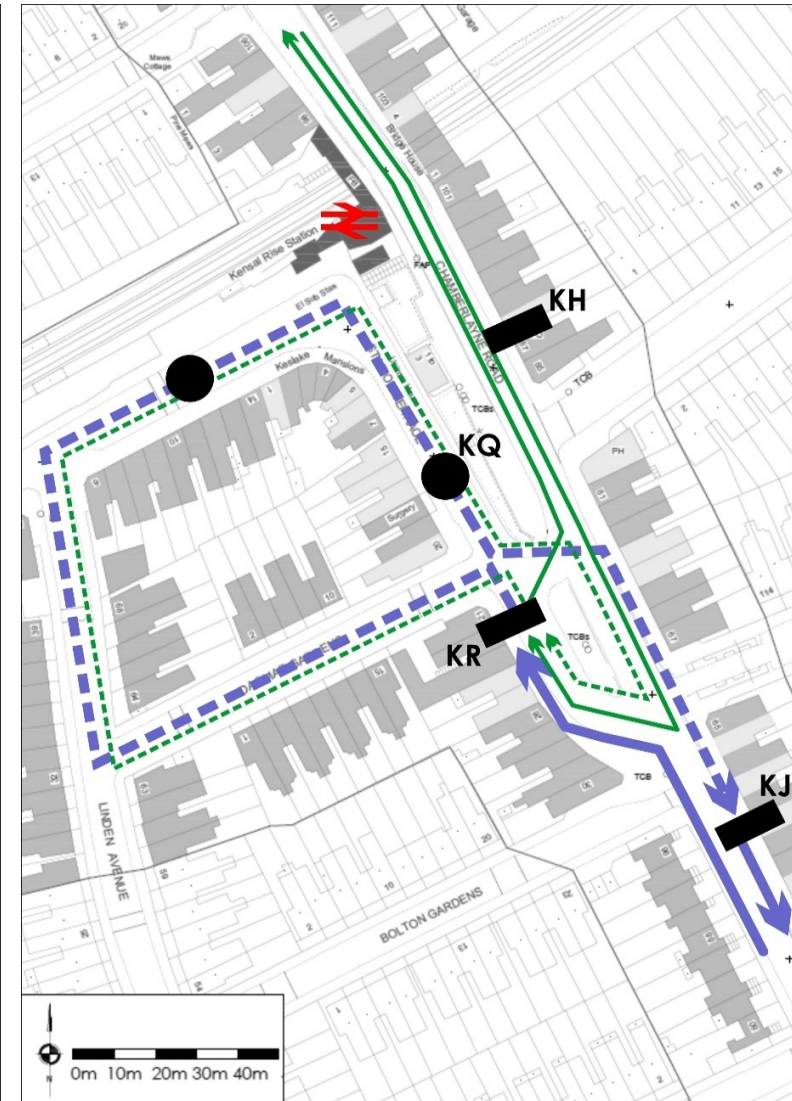
Les itinéraires à proximité de Station Terrace

Movement patterns of terminating buses in Station Terrace

Note: This diagram aims to show the convoluted routes for the terminating buses (28,302, 452) and their impact on the residential streets

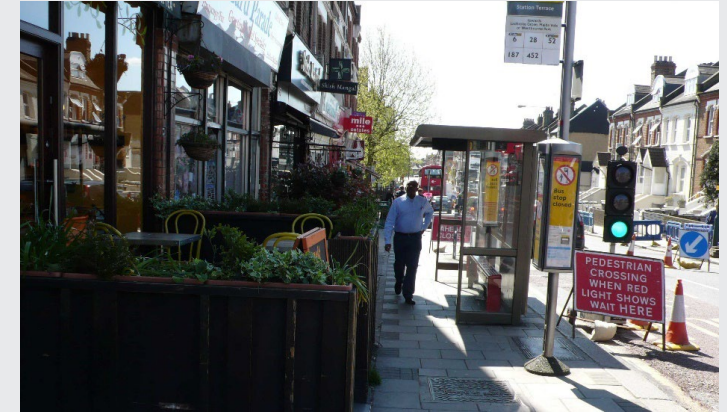
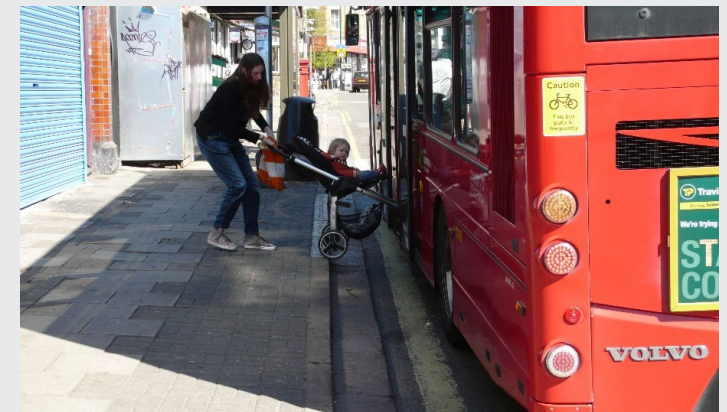
Audit des zones d'attente pour autobus

Bus Waiting Area Assessment		KR	KJ	KH	KT	KN	KP	KS	KM	KL	KK	KG
Total boarders and alighters per day		5835	3331	2956	2285	2059	1700	1536	1338	1237	1105	926
Accessibility of the waiting area and public transport (boarding/alighting)	Accessibility via pedestrian crossings											
	Dropped / raised kerbs and gaps minimised											
	User conflict											
	Visible and legible											
	Footways and surface quality (incl. tactile)											
Waiting area comfort	Access and egress points accessible											
	Shelter and protection from weather											
	Waiting area capacity											
	Seating visible / easy to reach / suitable	n/a		n/a								
Information at the waiting area	Nearby facilities											
	Timetables											
	Real time information											
Quality of the environment	Sense of Place											
	Aesthetics											
	Soft Landscape											
	Quality of materials / private frontages

Noise											
	Lighting											
	Litter bins provided											
	Level of cleanliness											
Safety perceptions	Safety from traffic											
	Evidence of graffiti or vandalism											
	Evidence of anti-social behaviour											
	Formal and/or informal surveillance											
	Sightlines
